HORNER AND SHIFRIN INC ST LOUIS MO
NATIONAL DAM SAFETY PROGRAM, LAKE ST. LOUIS DAM (MO 10545) MISS-ETC(U)
MAY 78
DACW43-79-C-0047

LAKE ST. LOUIS DAM
ST. CHARLES COUNTY, MISSOURI
MISSOURI INVENTORY NO. 10490

PHASE I INSPECTION REPORT
NATIONAL DAM SAFETY PROGRAM
LAKE SAINT LOUIS DAM - ID NO. 10490

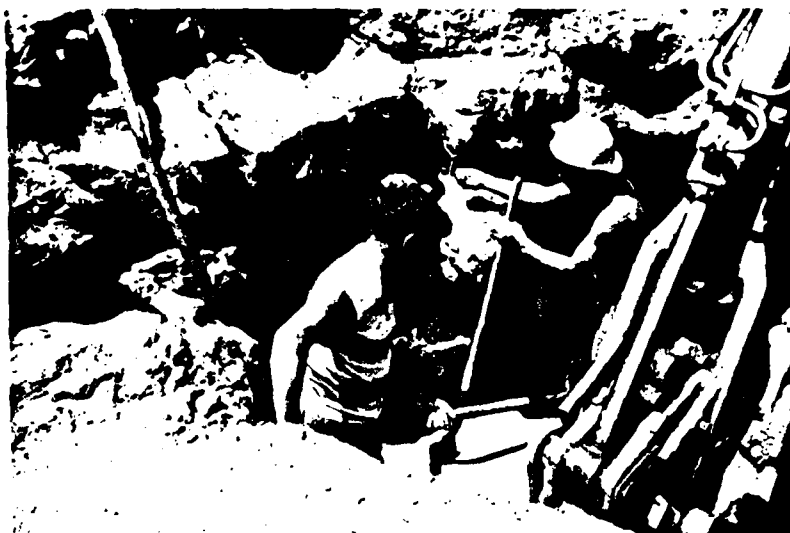
NO. 7: CLEANING CAVITY IN SPILLWAY FOUNDATION - STA. 5+75+

b. Spillway and Outlet Channel. Construction of the concrete spillway section was accomplished according to plan with the exception of the reach between stations 4+60 and 6+38. Due to poor rock foundation conditions, as indicated by the test borings, it was planned to construct an earthfill embankment section in this area. When excavation of the overburden in this area revealed that the foundation rock could be satisfactorily utilized, and at the request of the developer, it was decided to extend the concrete overflow section through this reach and eliminate the earthfill embankment. Considerable effort was expended removing badly weathered rock, cleaning the earth

filled cavernous rock areas, and filling with concrete the resulting voids within the limits of the overflow section in order to attain a sound, impervious foundation. Photographs taken during construction showing an area of the cavernous rock foundation that has been prepared for filling with concrete, as well as other photographs taken during construction of the spillway overflow section, are included on Pages A-2 through A-5 of the Appendix.

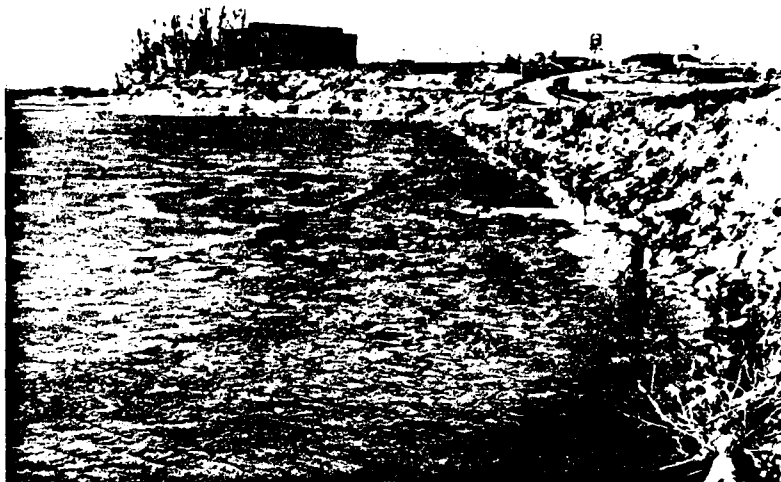
NO. 11: UPSTREAM FACE OF DAM

b. Dam. The upstream and downstream slopes of the dam were found to be in good condition except for some erosion, caused by surface storm runoff, of the downstream slope where the dam joins the east abutment and of the upstream slope at the east abutment of the Lake Saint Louis Boulevard Bridge.

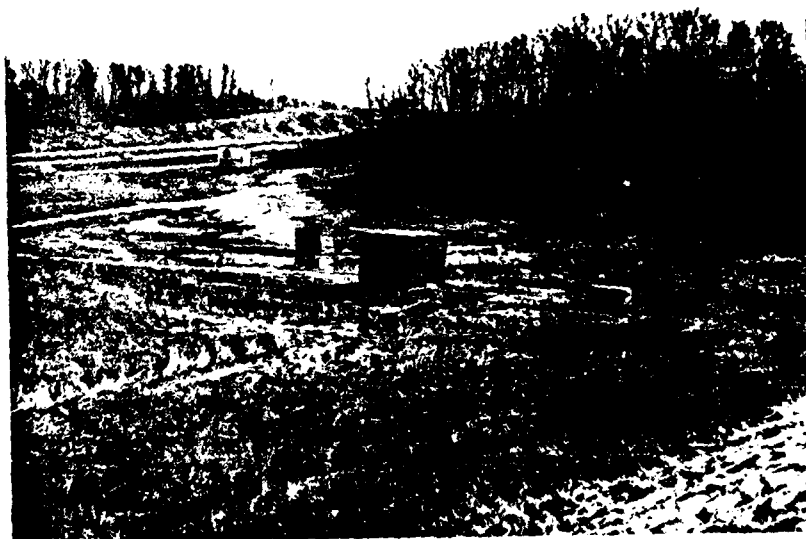
NO. 14: SEWAGE LIFT STATION

The downstream flood plain adjacent to the dam was also noticeably wet, with ponded water appearing in several locations, however this condition can be attributed to poor drainage of surface runoff and to overflow of the sewage lift station wetwell. Details of the sewage lift station and wetwell are shown on Plate 15.
